Rectification and Analysis of Water Intrusion in the Vehicle

Gautam A. Ghabade #1, K.H.Inamdar *2

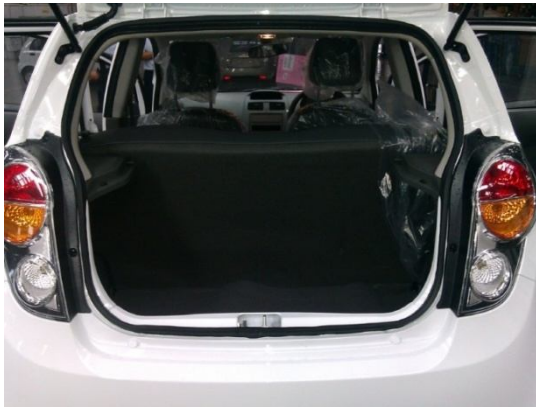
After shower testing of vehicle, it is found that the water leakage was occurring in tailgate area. It is consider as 20 pointer defect at Quality level i.e. in GCA. Below figure shows the area where the water leakage problem was occurring.

Fig.1. Tailgate water leakage area

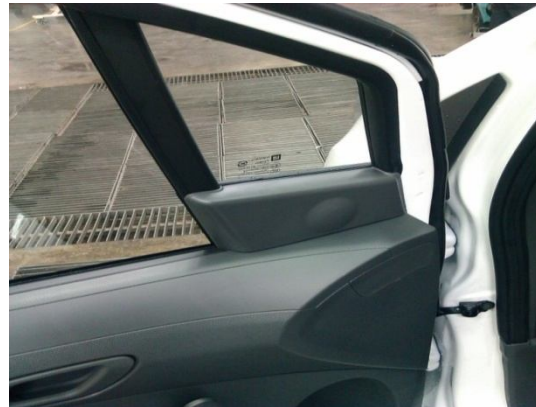
Fig. 2. Door water leakage area

The car body is assembled by thousands of weld points. At tailgate there are two different panels attached with the spot welding. So at corner section if weld points are came inline the flange will remain straight but if the weld points shift from their mean position, then the flange will bend and this causes improper fitment of weather strip. This happens because of wrong process followed by worker. Sometimes worker is not skilled worker, then also the weld points do not come inline. As showed in fig. 3. The door water leakage is also occurred due to uneven body flange where fixed glass is fitted. It is having the same reason as tailgate water leakage due to flange bend. So the run-channel was not properly fitted, and from that point water leakage was coming inside the door area.

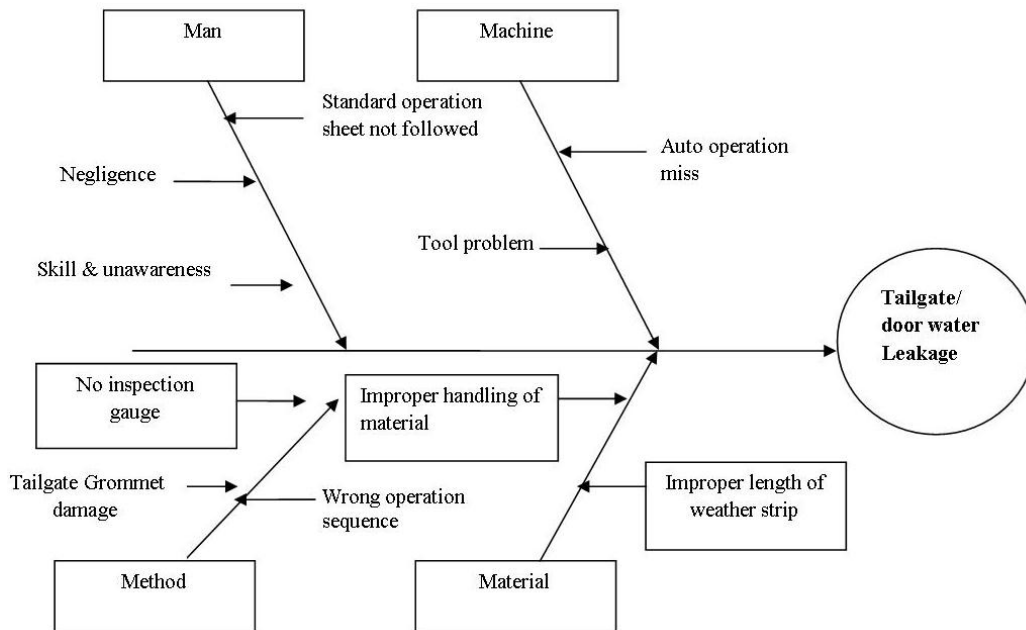
The cause and effect diagram indicates that there are mainly four resources of causing the defect. Also it indicates all possible causes from the resources. Check each and every parameter to cause defect, and after study we found that the causes in boxes as shown in fig. 3. are the root causes of the defect. The tailgate water leakage is occurred mainly due to flange bend at corner, improper handling of material and improper length of weather strip.

Fig.3. Cause and effects diagram for tailgate / door water leakage

As this defect is occurred due to process issue and we can't do anything to reduce man to man variation. So to prevent the water intrusion in this case, the flange should be inspected 100% in both cases i.e. tailgate water leakage and door water leakage. For this the special gauge is made. Gauge made from the readings of 50 ok vehicles in shower tester in case of tailgate water leakage. For door leakage, gauge made as per drawing of fixed Glass. 100 % vehicle inspection introduced in GA shop before glass fitment. The inspection gauge is shown in fig. And 100 % vehicle inspection is performed for body flange as shown in fig 5. After inspection if any defected vehicle is found, it has to hammer properly to make flange straight.

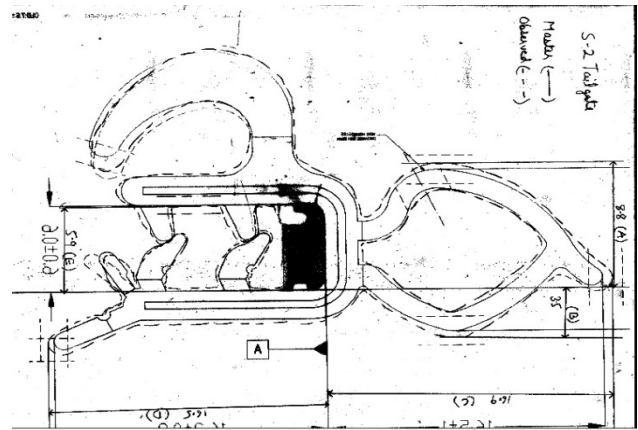
Fig. 4 shows cross section of weather strip and 10x profile of it. In fig. 5 continuous line is master drawing and dotted line is of observed profile. The inspection report is showed in following table. It is seen from table that 10x profile of weather strip is within the tolerance so no issue found in it.

Fig.5. 10x profile of weather strip

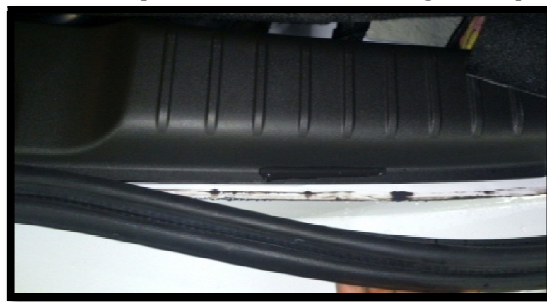
And got results as the 10x profile was as per drawing but length of weather strip was less than specified. 20 samples of weather strip had cut and checked for its length and found average actual length of weather strip was 3020mm. But as per drawing it should be 3046 ±7mm. So after discussion with supplier regarding this issue and we came to know that when weather strip is manufactured, it is cut at specified length while it is in hot condition. But after getting cold it compresses in length slightly, which may lead to improper fitment of weather strip and finally in water intrusion in car as shown in below fig. 6.

Fig.6. Improper fitment of weather strip

It is necessary to discuss with supplier and asked him to provide weather Strip length as per the drawing. Insure from him to cut weather strip at 3065mm in hot condition so that after getting colder it will achieve required length.

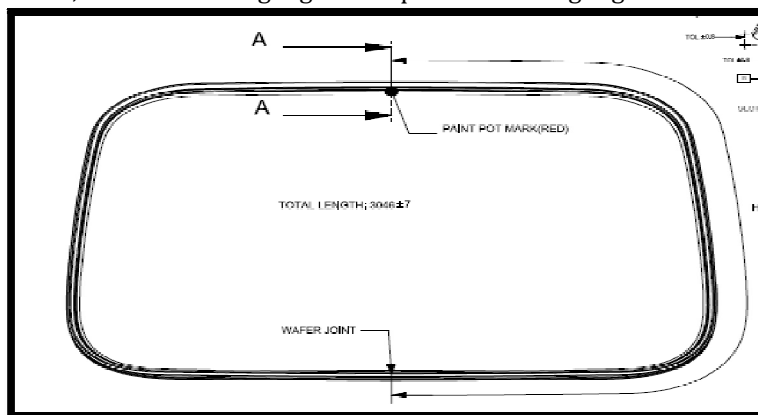
After finding out the results about 10x profile, now it is necessary to check actual length of weather strip. Actual length of the weather strip is measured and checked with the drawing. As per drawing shown in fig. 7, the length should be 3046 ± 7 mm. But actual length of weather strip is found as 3020mm, 3015mm and 3020mm, which is out of tolerance. So the main problem is found in length of weather strip.

Information about this issue is given to supplier and discussed with him. Then it is found that weather strip manufacturing process was incorrect. Weather strip is manufactured as a single strip. Then it is cut at particular distance when it is in hot condition and then joined it. Supplier was cutting the weather strip at 3048mm and joined it, but after cooling it gets compressed. So length got reduce.

Fig.7. Actual drawing of tailgate flange area

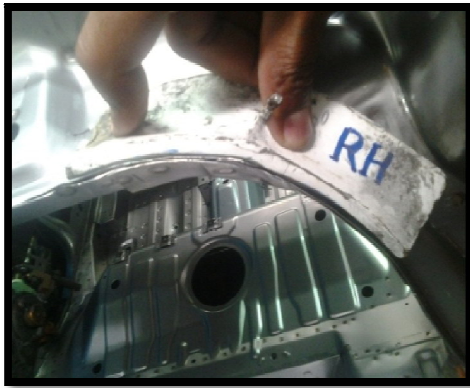
Fig. 8. Implementation of inspection gauge for tailgate water leakage

As discussed above, the reasons for water intrusion are body flange bend and improper length of weather strip. So to avoid the water intrusion, it is necessary to do process control which is really hard job, as it involves man to man variation. Hence the special gauges as shown in fig. 8 &9, were made for 100% inspection and in not ok vehicles, it is important to make flange straight by hammering it.

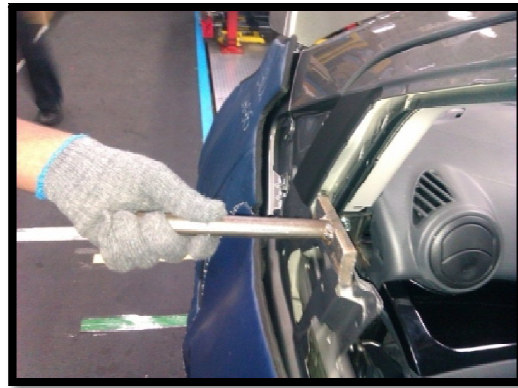
Fig. 9. Implementation of inspection gauge for door water leakage
