Rectification and Analysis of Water Intrusion in the Vehicle

Gautam A. Ghabade #1, K.H.Inamdar *2

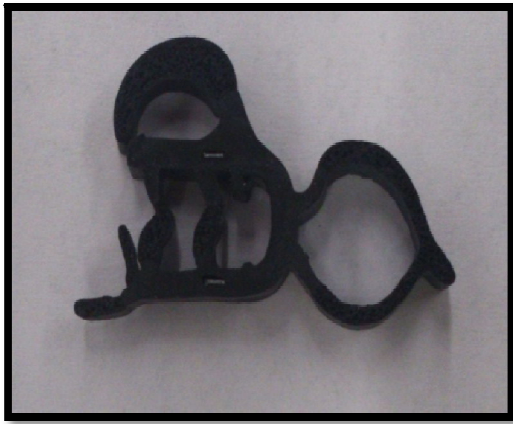
Fig. 4 shows cross section of weather strip and 10x profile of it. In fig. 5 continuous line is master drawing and dotted line is of observed profile. The inspection report is showed in following table. It is seen from table that 10x profile of weather strip is within the tolerance so no issue found in it.

Fig.4. Cross section of weather strip
